# WOOD DESTROYING ORGANISM

**APR 07, 2023**

1234 Sample st

WOOD-DESTROYING ORGANISMS INSPECTION REPORT

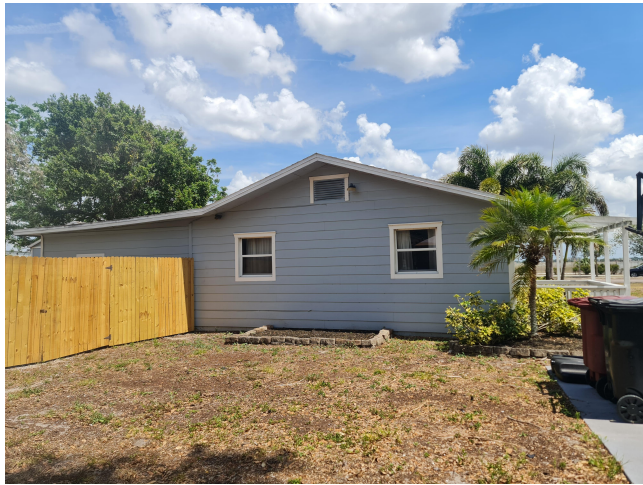
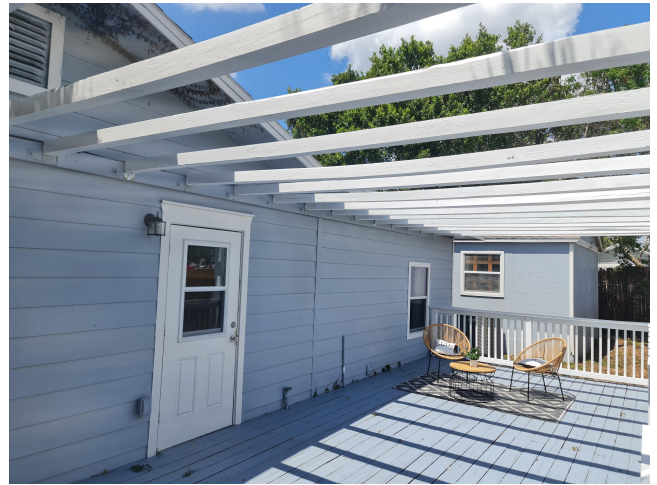
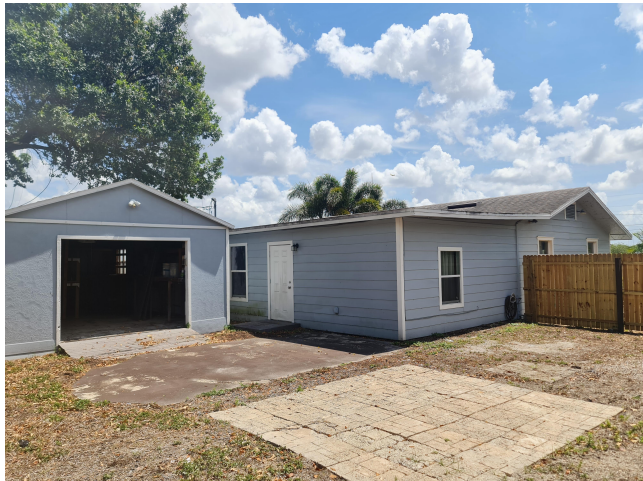
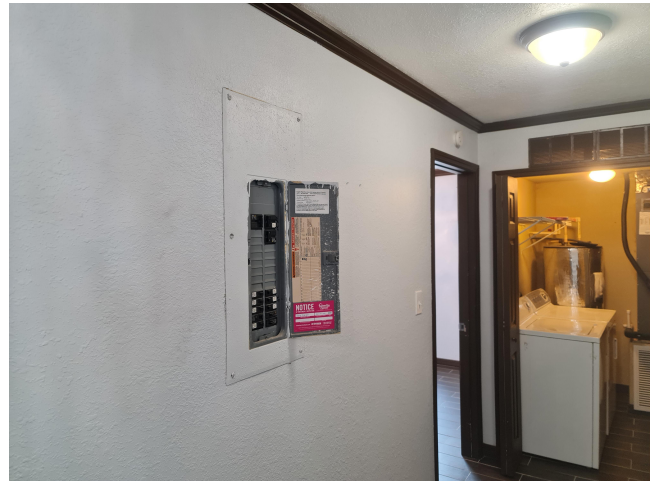
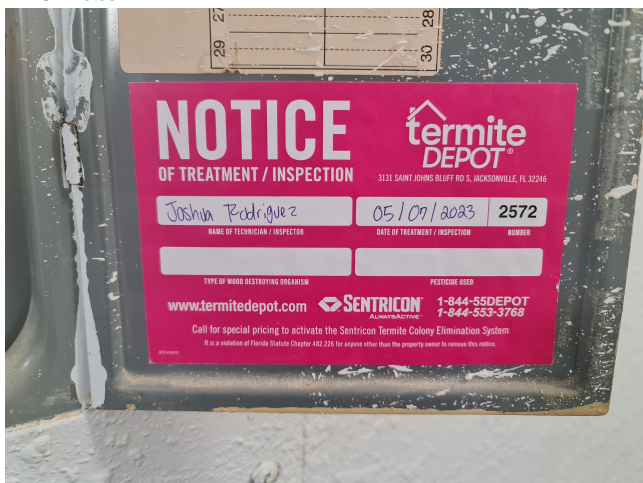
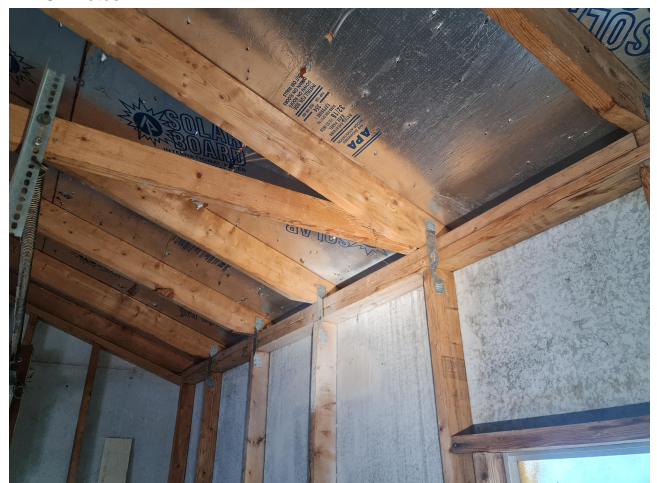
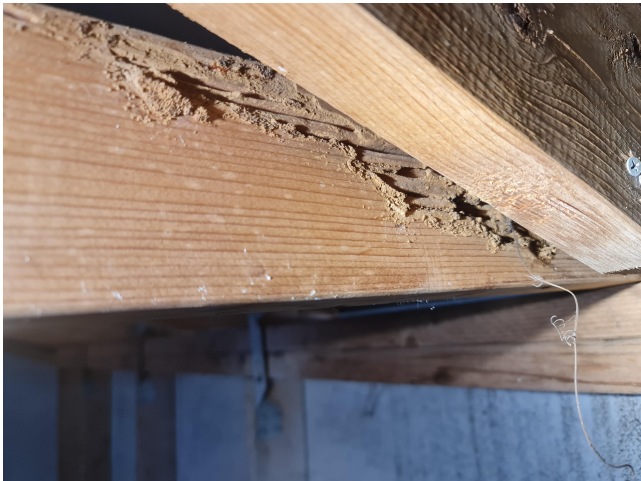
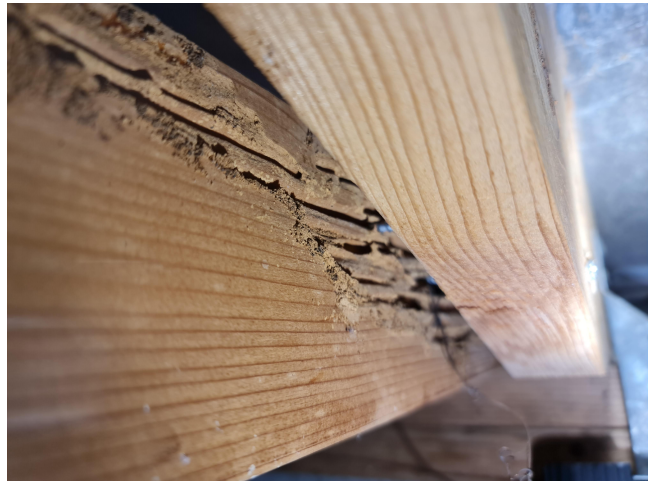
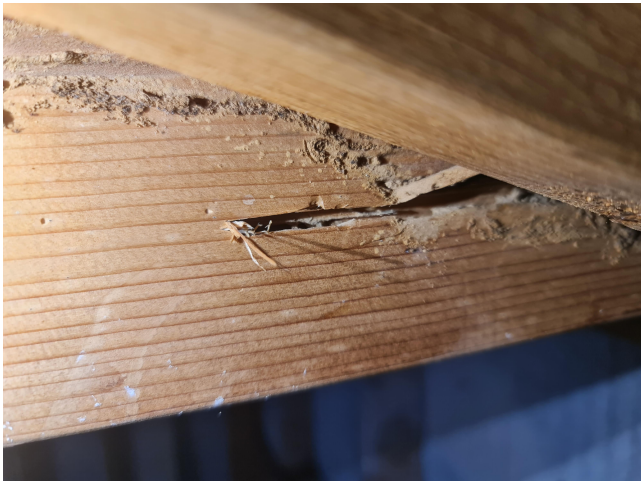
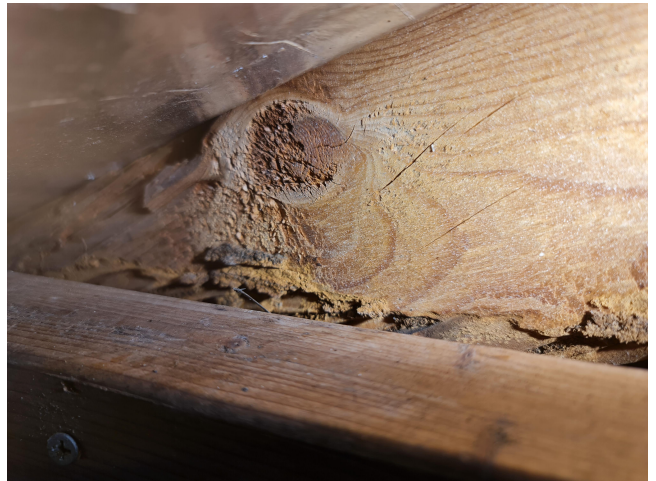
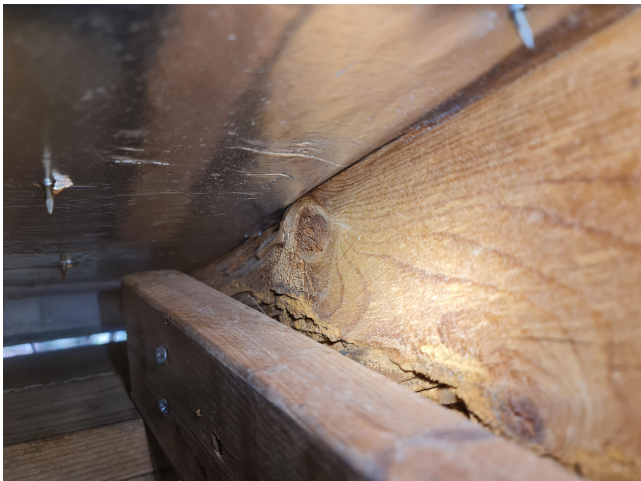
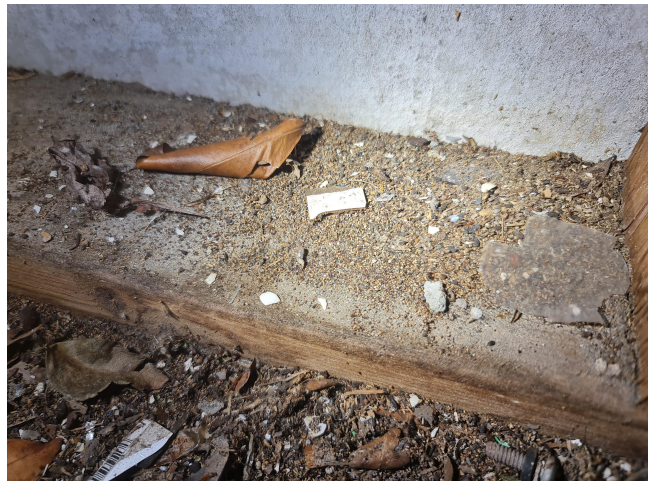
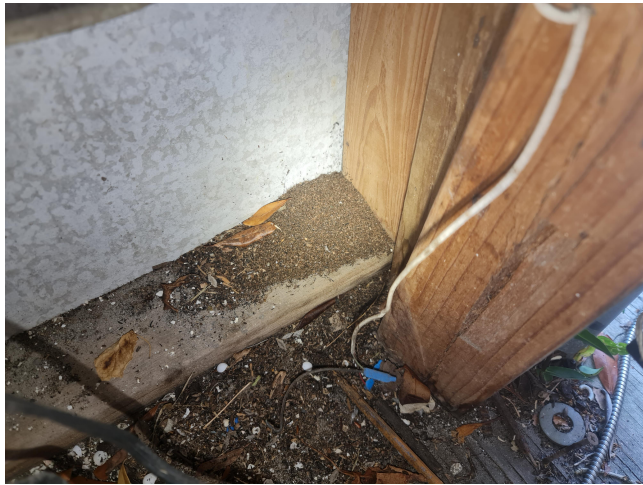
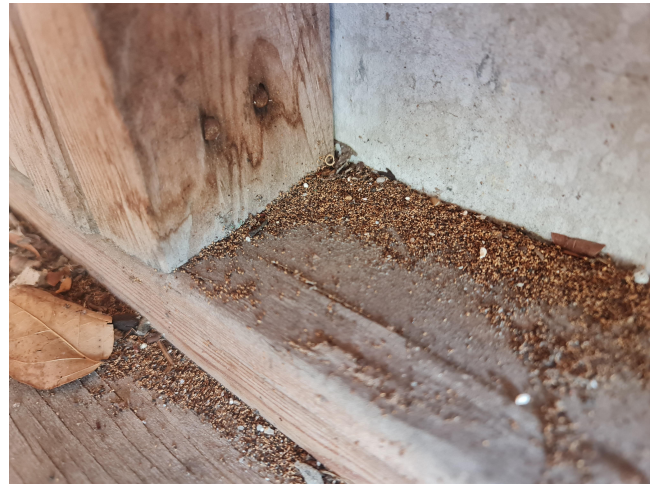
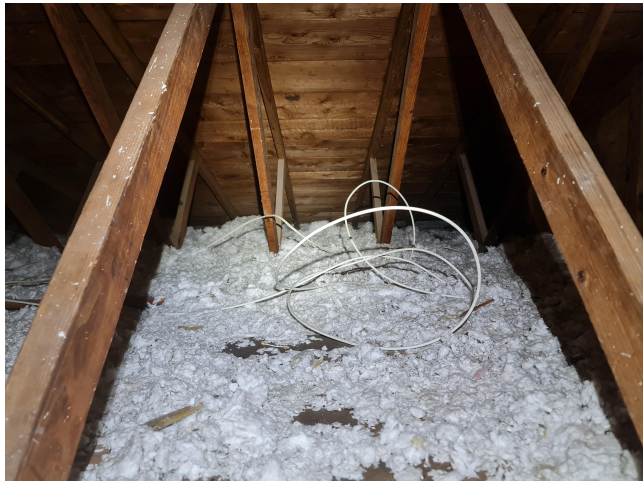
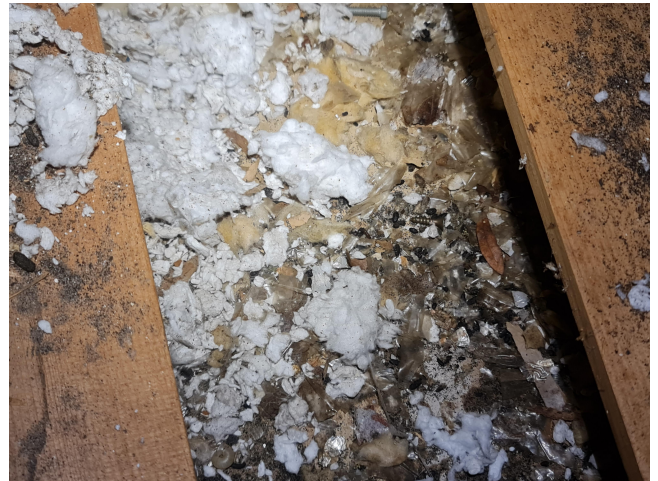
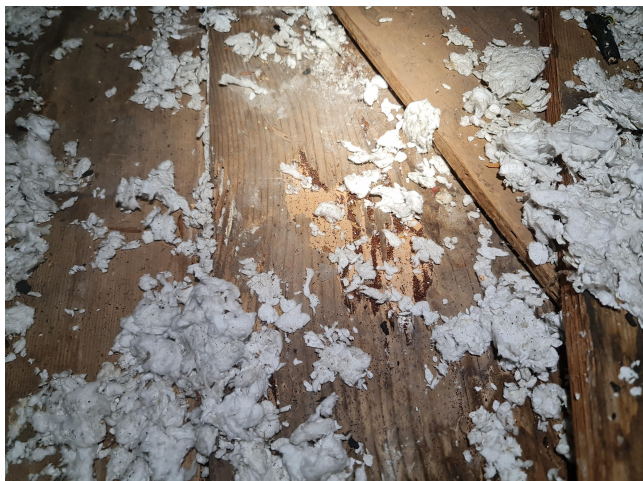
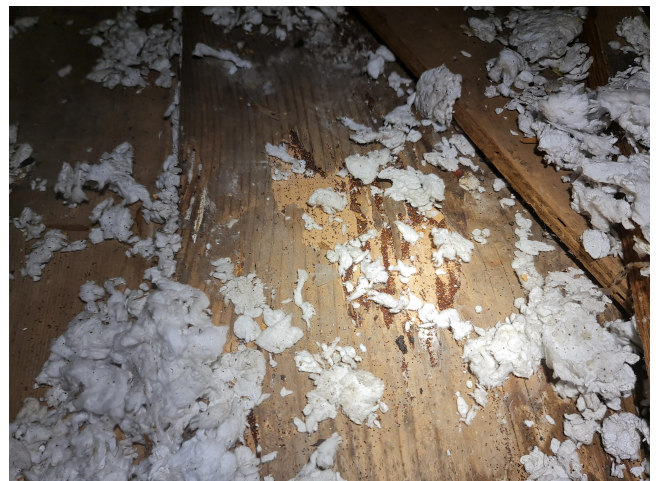
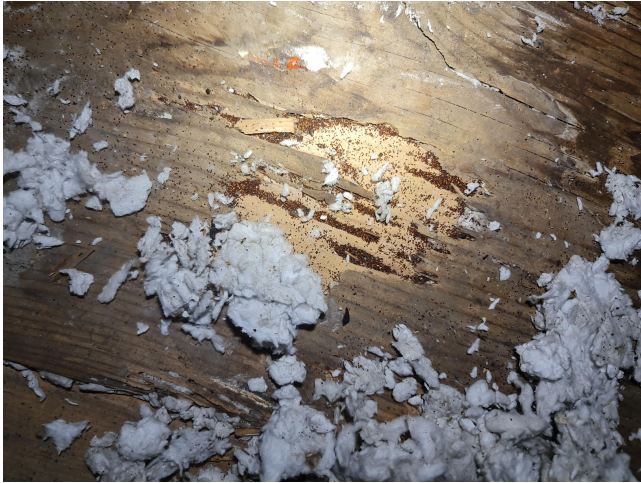
Termite frass found. Mud found in Sub termite galleries.

Evidence of drywood & subterranean termites was observed in the attic of the home and the barn. The evidence was in the form of termite galleries and frass. Mud is seen in the Sub termite galleries.

damage/evidence is adjacent to a wood frame area, wall coverings would need to be removed to visually determine the extent of any possible hidden damage. If this house is not currently covered by a Drywood Termite warranty/guarantee, I would recommend that this house be treated for Drywood Termites by whatever means the purchaser & treating company agree to. A typical warranty for this treatment would be for one year initially, with annual renewal options available thereafter. It is very important that any treatment performed results in a warranty on the entire structure.

This house or portions of this house are built with wood frame construction. Subterranean Termite evidence, and/or damage, has been discovered in a wood frame area. To visually determine the extent of any possible hidden damage, wall coverings would need to be removed so the wall framing would be visually accessible. A wood destroying organism inspector could determine the extent of any possible hidden damage, once the wall coverings have been removed, but a structural engineer or licensed general contractor is best suited to determine how the repairs should be done. When removing wall coverings, the initial cut should be sufficiently large so the inspector/contractor is able to visually examine the framing members adjacent to the originally reported damaged area. This removal of wall coverings should continue both horizontally and vertically until no more damage is observed. It is usually best to examine all areas adjacent to the damaged area as termites can skip over some wall studs/framing members and re-appear further up/down the wall. To make a visual determination of live infestation in the previously inaccessible areas, such as inside the wall, a W.D.O. Inspector, or an appropriately qualified building trade expert could probe the wall framing after the wall coverings have been removed, but before any repairs are made to the wall framing. To determine if all of the damaged wood was replaced, a W.D.O. Inspector, or qualified expert of the building trade should view the repaired area before insulation, and drywall or other wall coverings are put in place. If a "clear" inspection is needed, this must be done by the WDO inspector. If the house is under an active termite "warranty", "bond" or "bait program" of any type, a representative from the company that directs that program, should be notified immediately, so they may take any actions they might deem appropriate in accordance with their policies. If no warranty is currently in place on the property, we recommend that the house be treated for Subterranean Termites, by a professional pest control company licensed to do so in the State of Florida. This type of treatment typically carries a one year warranty, renewable thereafter, on a year to year basis. Some warranties are for re-treatment only, while other warranties cover re-treatment as well as the repair of any "new" Subterranean Termite damage. Subterranean Termites live in colonies underground which cannot be located. The colony which has attacked this structure cannot be located, therefore, we recommend that any treatment be of the entire structure, or at a bare minimum, that the treatment performed results in a warranty being placed on the entire structure, and since this is a wood frame structure we recommend that the warranty include a provision for the repair of any new damage.
