HUD
Engineering Certification
Report

1234 Sample

Lakeland, FL

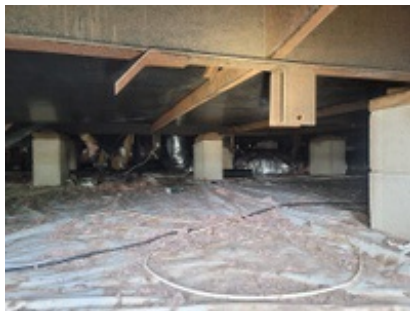
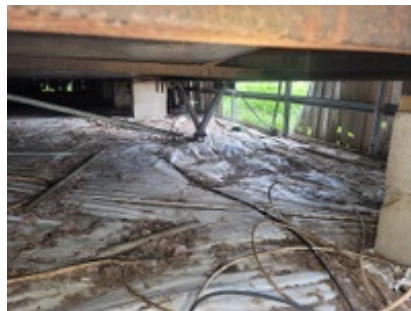
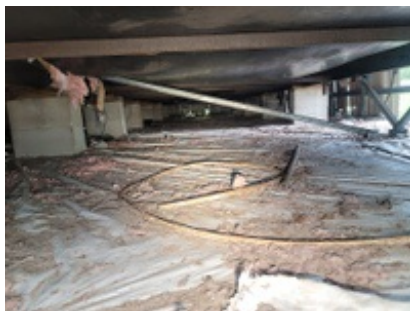
1.17 Foundation Type Images

Crawlspace

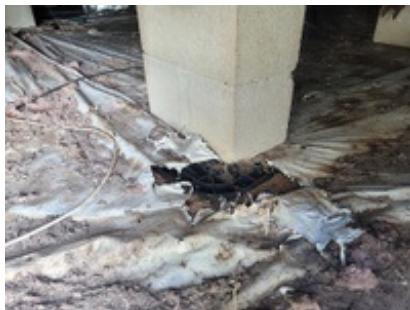
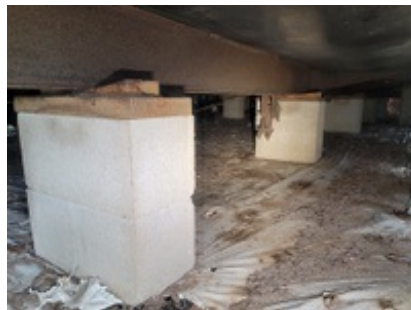
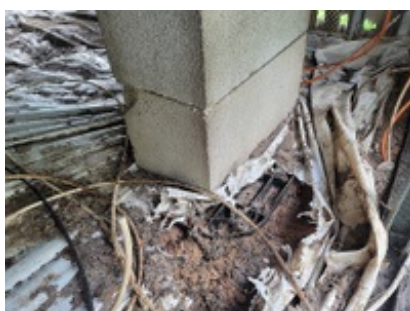
1.19 Piers Images

Dry-stacked Masonry Blocks

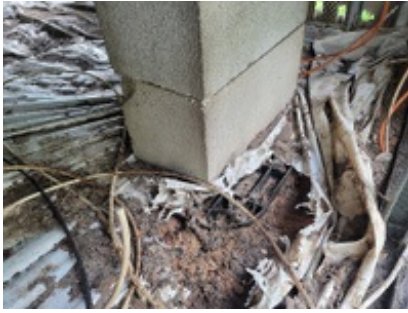
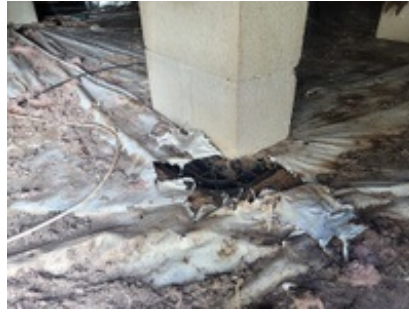
1.21 Piers Rest On Images

Plastic Pad

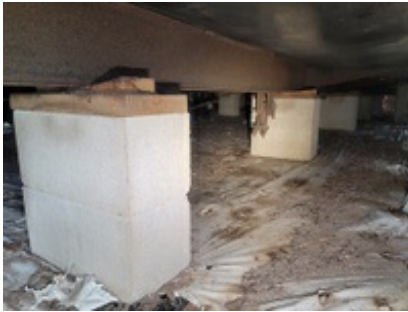
1.23 Wheels Images

Wheels and axles are Removed

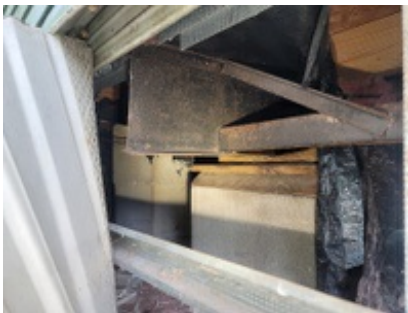
1.25 Tongues Images

Removed from Frame

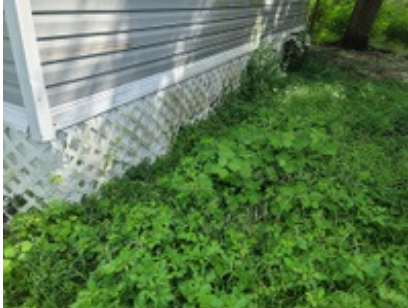
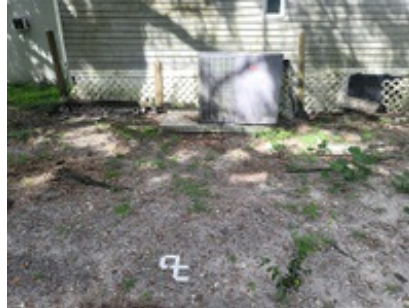
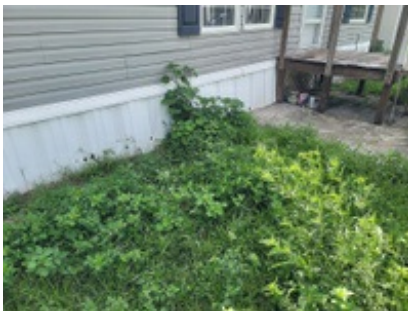
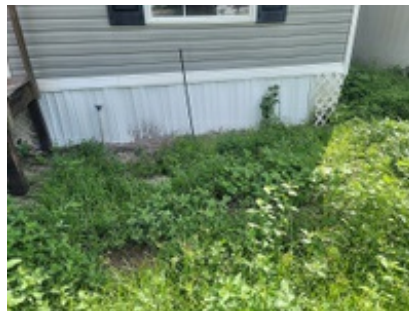
2.2 Exterior Grading Images

Reasonable grading around the home.

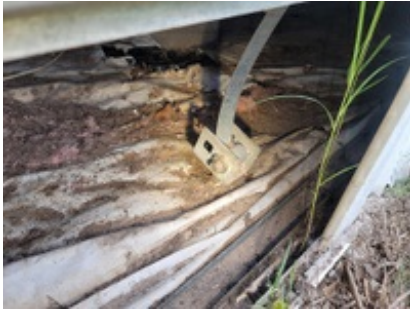
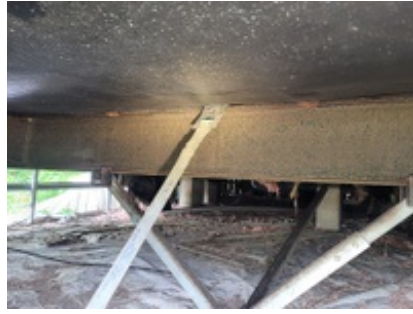
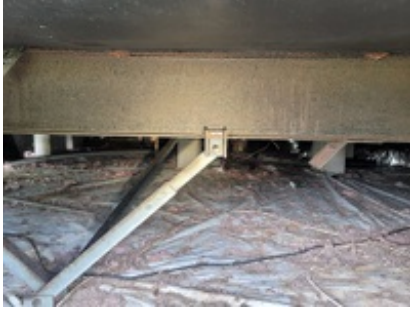
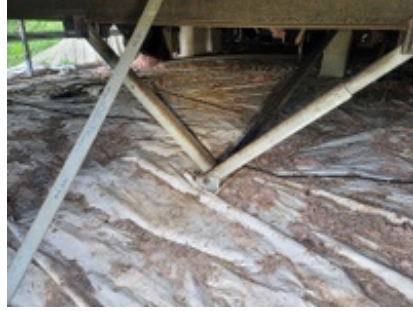
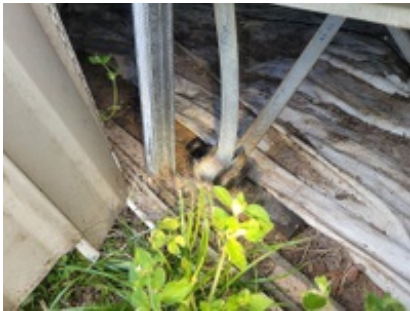
2.5 Anchor Method Images

Metal Straps connected to anchors augured into the soil and Proprietary Restraint System.

Approximately every 4 feet.

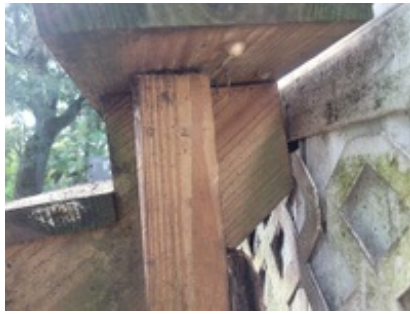
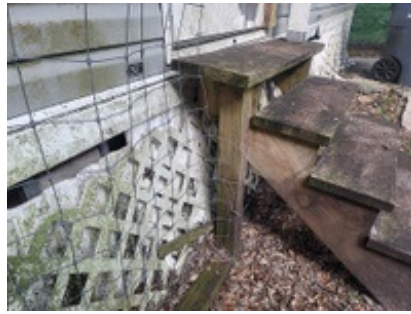
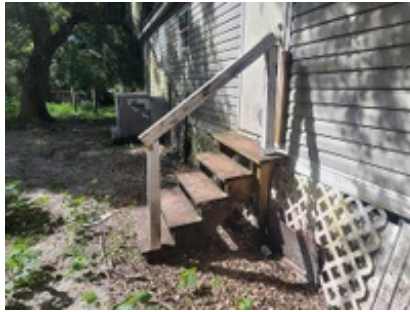
3.4 Floor Structure Images

N/A: Independent posts next to the home support the portion of the floor structure which is up against the home.

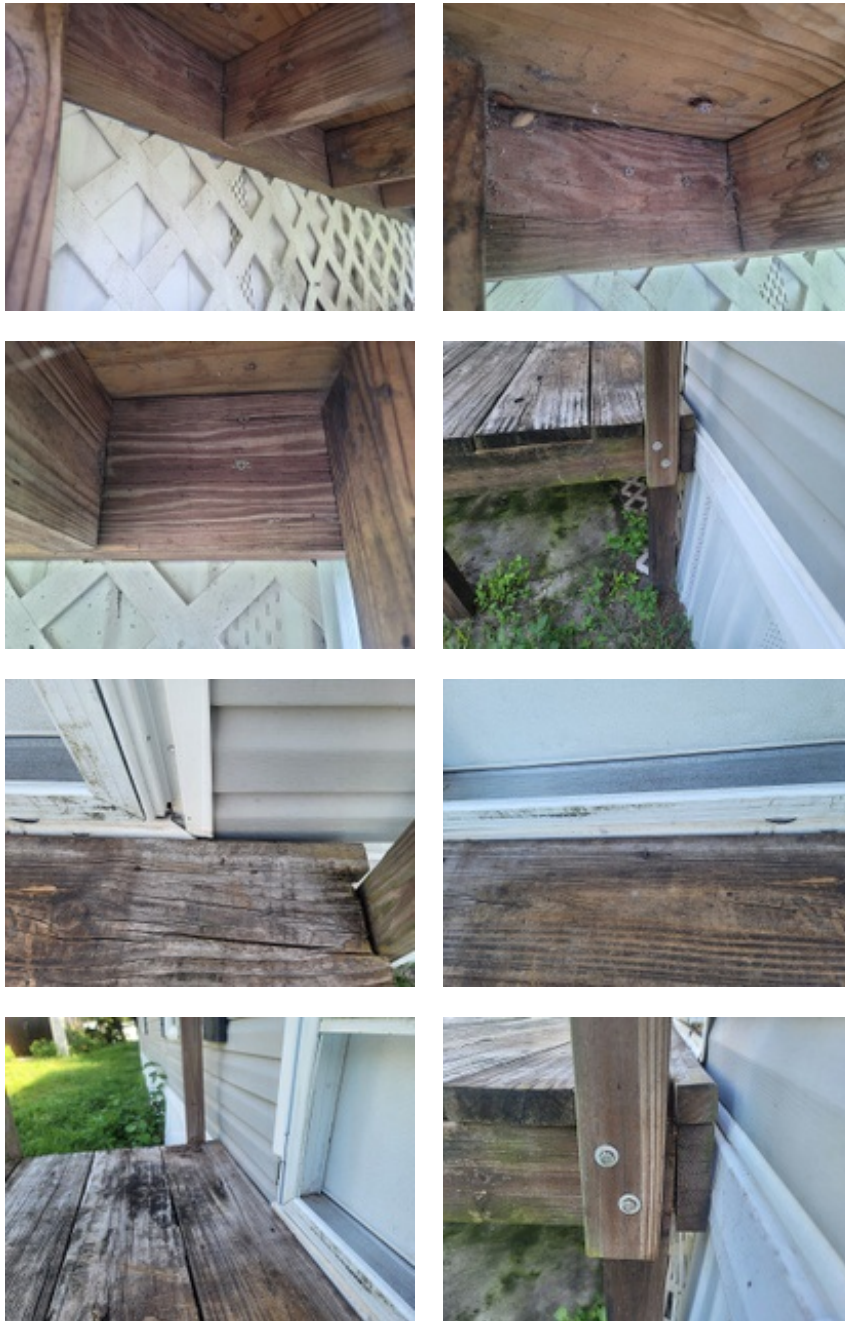
3.10 Floor Structure Images

N/A: The Independent posts are connected up against the home by a 2x6 board and drywall screws. The deck is supported by independent posts. The age of the addition appears to be older material.
