HUD Engineering Certification Report

1234 Sample Rd
Saint Cloud, FL

HUD Engineering Certification Report Summary

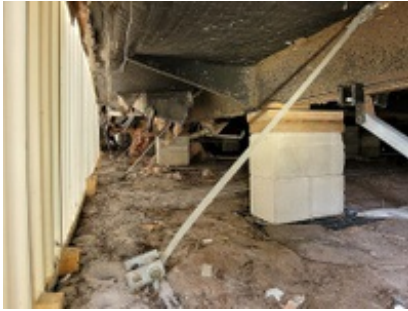
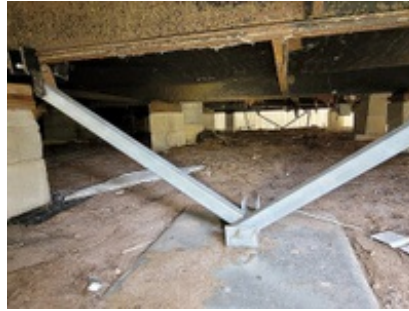
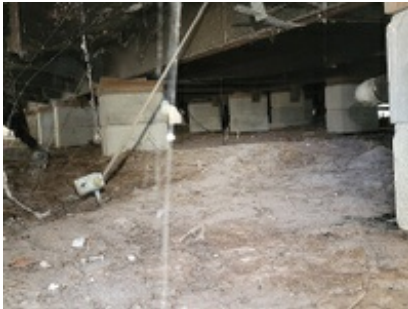
1.17 Foundation Type Images

Crawlspace

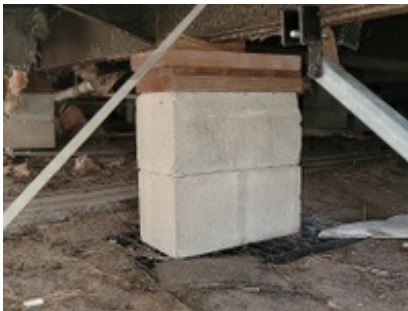
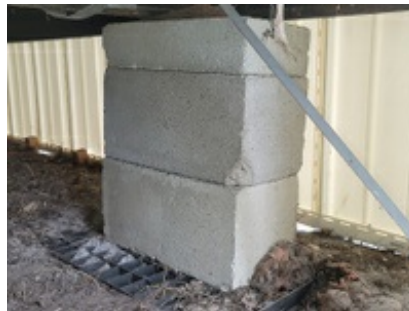
1.19 Piers Images

Dry-stacked Masonry Blocks

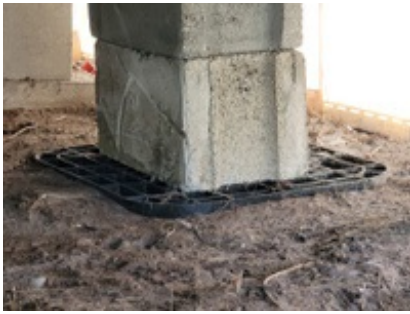
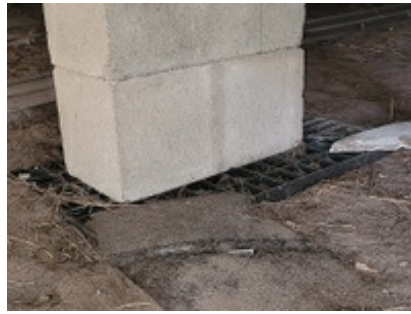
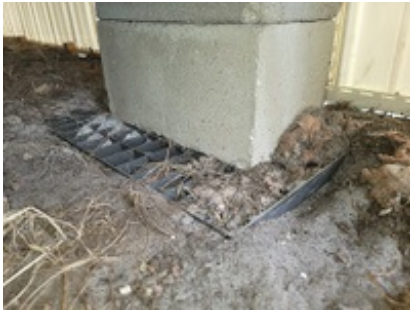
1.21 Piers Rest On Images

Plastic Pad

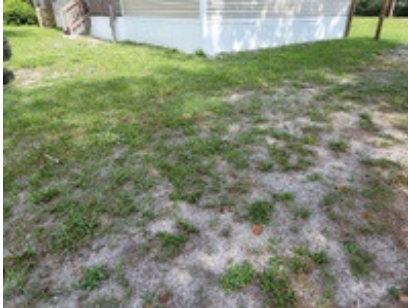
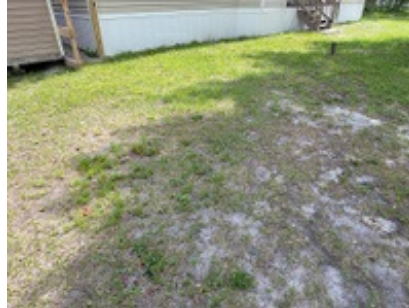
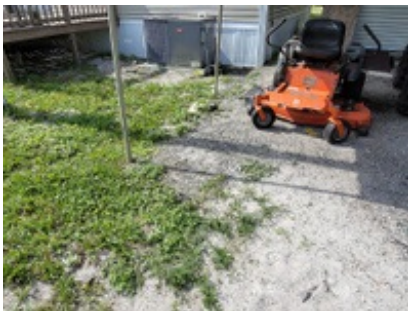
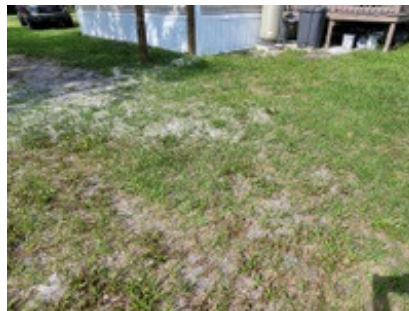
2.2 Exterior Grading Images

2.1 Exterior Grading

Reasonable grading around the home.

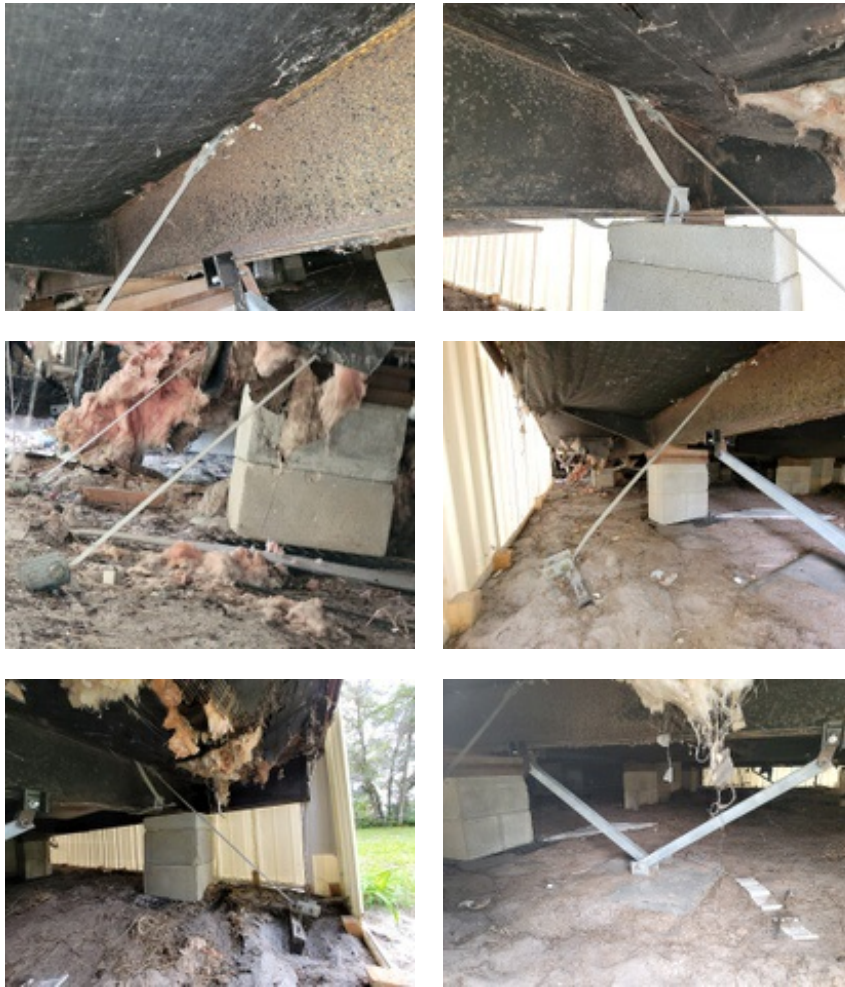
2.5 Anchor Method Images

2.4 Anchor Method

Metal Straps connected to anchors augured into the soil and Proprietary Restraint System.

Approximately every 5 feet.

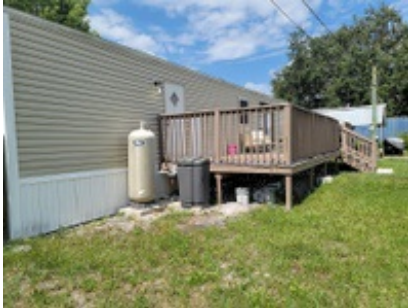
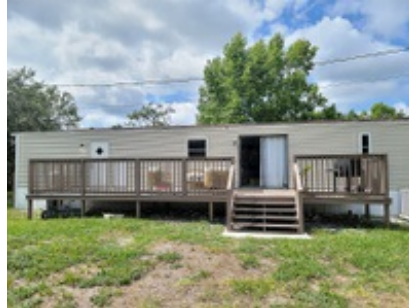
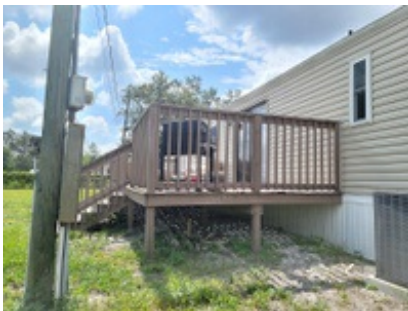
3.2 Images

The Mfd. home **does not appear to have been** modified or altered with respect to this addition.

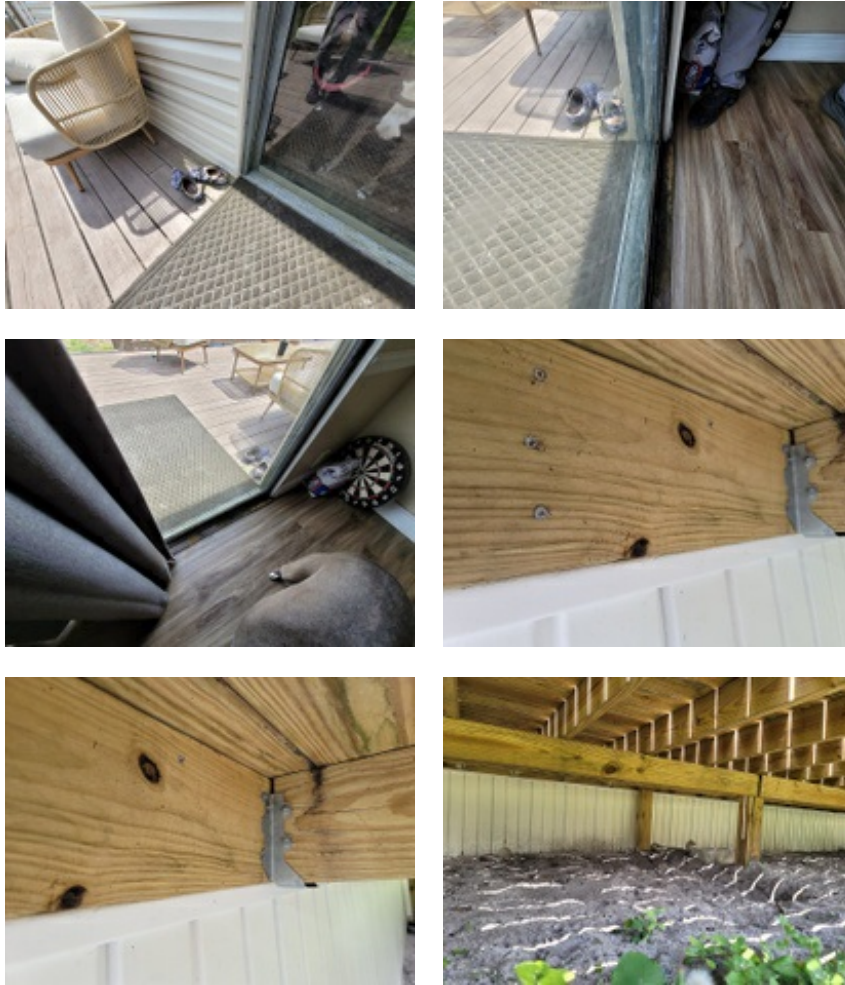
3.4 Floor Structure Images

3.3 Floor Structure Assessment

Loads are being transferred from the floor structure onto the structure of the manufactured home.

Loads of potential significance are being transferred from one or more additions onto the manufactured home. The manufactured home is not in compliance with HUD Guidelines. See the additions section of the main report for more information/clarification.

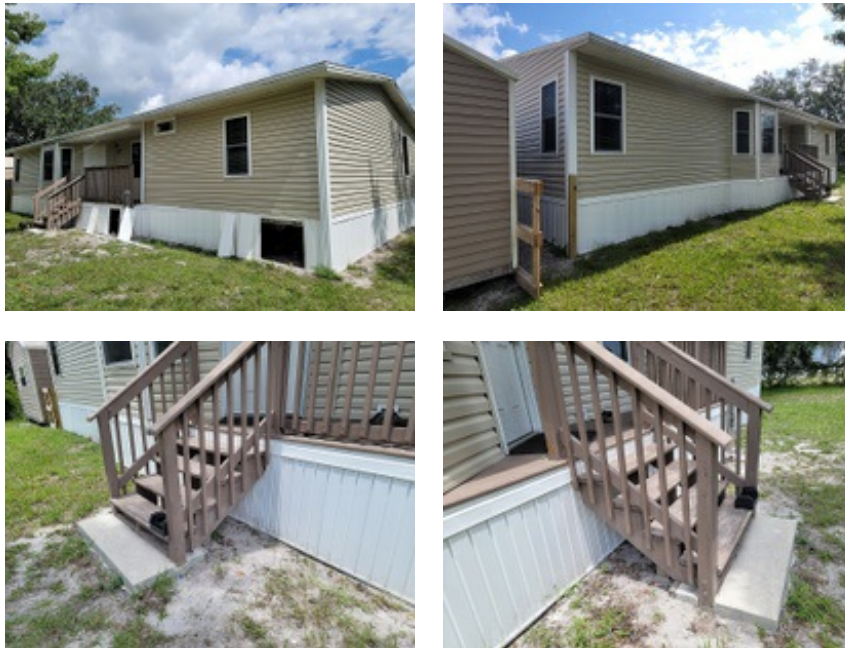
3.8 Images

The Mfd. home **does not appear to have been** modified or altered with respect to this addition.

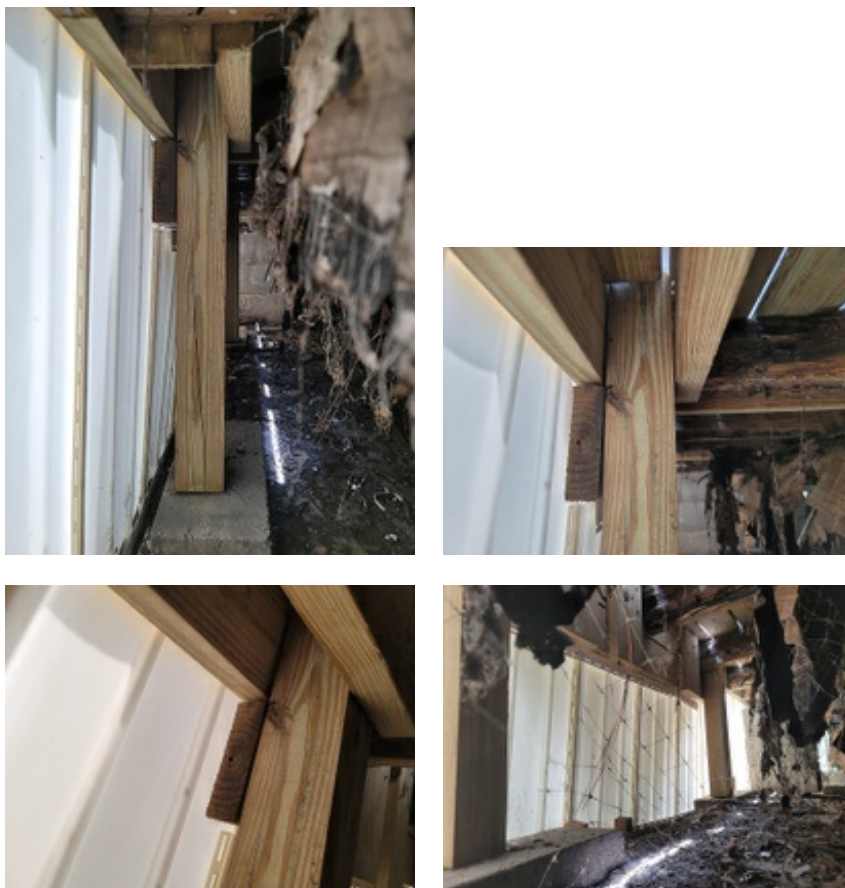
3.10 Floor Structure Images

3.9 Floor Structure Assessment

N/A: The stair stringers are attached to a ledger board with toe nails and the ledger board is attached to the rim joist with lag bolts. There are two posts under the rim joist at the stairs. There is no evidence that the structure of the manufactured home is being compromised. The age of this addition is unknown.
