Inspection Report

Property Address:
1234 Sample St.
Sample FI 123400

2020 Inspection Solutions

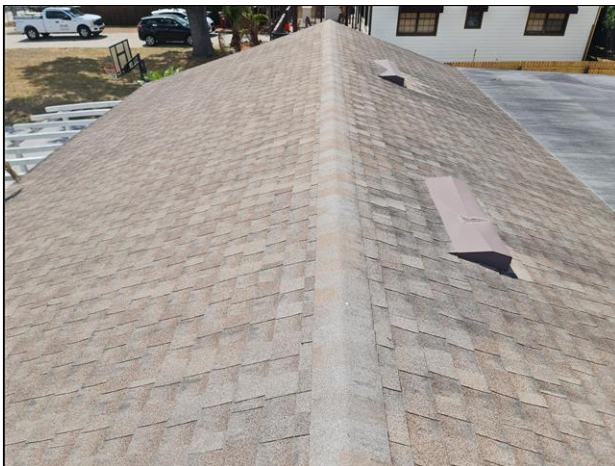
1.0 Item 1(Picture)

(1) The roof covering was in good condition at the time of inspection. According to the permit on record the roof was installed in 2016.

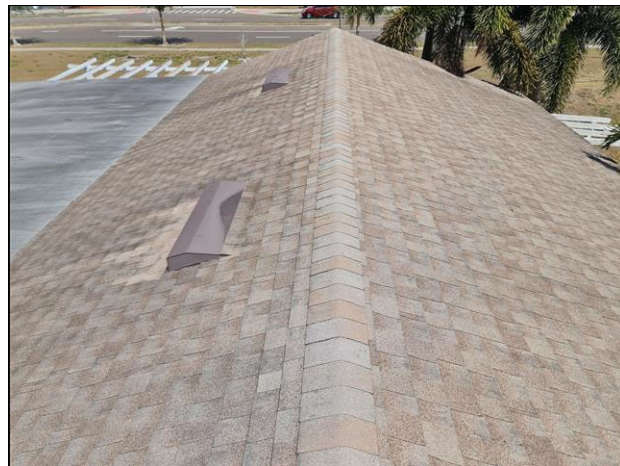
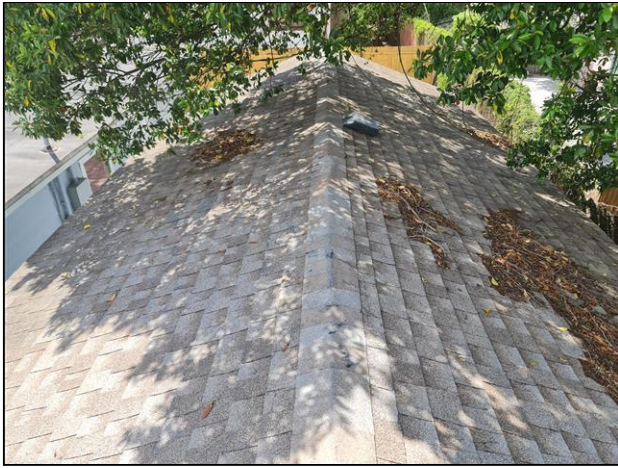
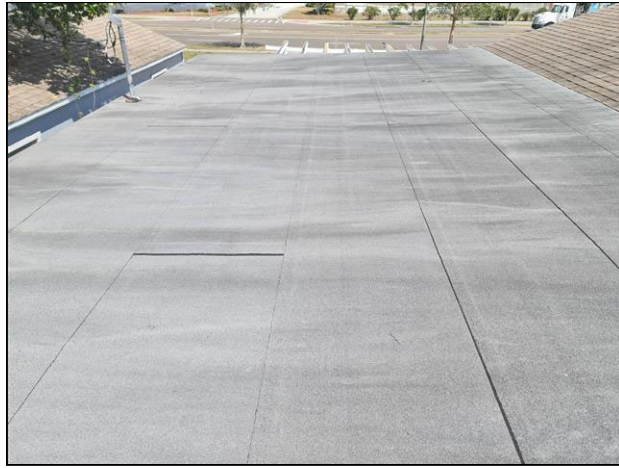
(2) The roof covering has curled or brittle membrane (modified bitumen) at the several areas of the roof. This area should be repaired or replaced This area may leak in the near future. I recommend monitor and repair or replace if the problem continues or becomes worse.

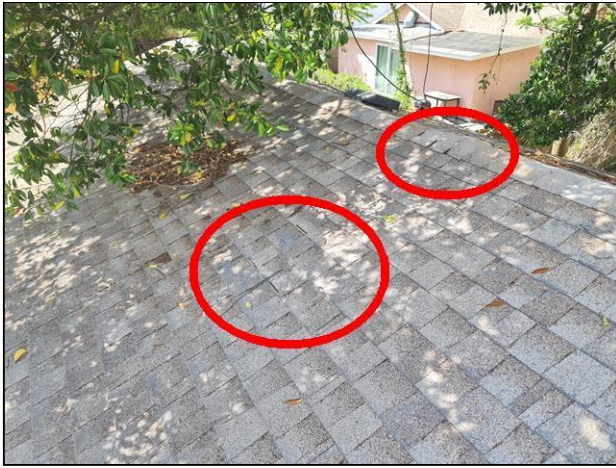
1.0 Item 8(Picture)

(3) The roof covering has excessive granule loss and damaged shingles at several areas of the roof. This area should be repaired or replaced. A qualified person should repair or replace as needed.

(3) The roof covering has excessive granule loss and damaged shingles at several areas of the roof. This area should be repaired or replaced. A qualified person should repair or replace as needed.

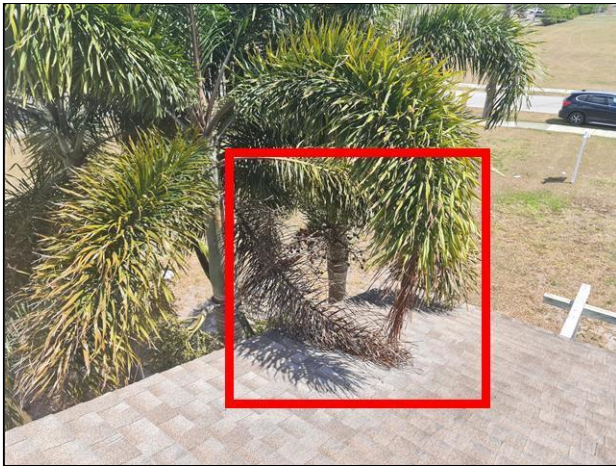
1.0 Item 12(Picture)

(4) The tree limbs that are in contact with roof or hanging near roof should be trimmed.

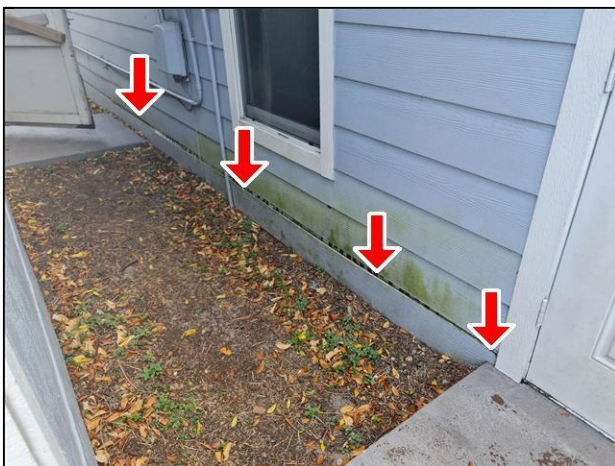
2.0 Item 1(Picture)

The cement board is loose or not secured at several areas of the home. Deterioration can eventually occur if not corrected. I recommend repair as needed.

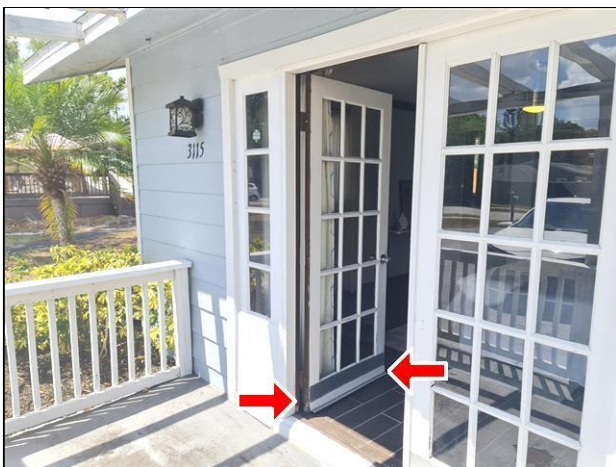
2.1 Item 1(Picture)

**The entry door is deteriorated at the bottom at the front of home. This is a maintenance issue and is for your information. I recommend repair as desired.**

The entry door is deteriorated at the bottom at the front of home. This is a maintenance issue and is for your information. I recommend repair as desired.

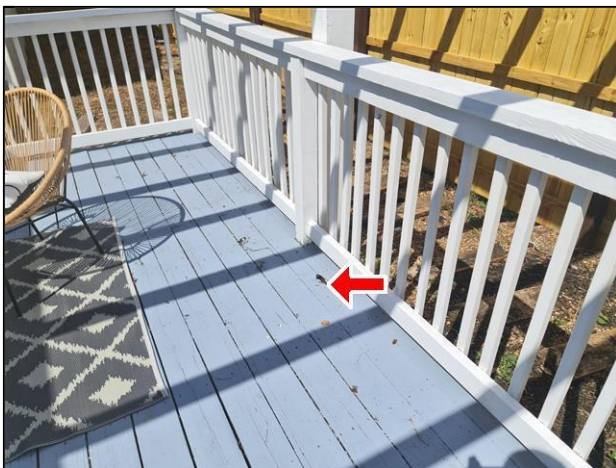
2.3 Item 1(Picture)

🏠 (1) The deck floor is deteriorated in several areas on the covered porch at the right side (facing front). Water can cause further deterioration if not repaired and sealed properly. I recommend repair as needed.

(1) The deck floor is deteriorated in several areas on the covered porch at the right side (facing front). Water can cause further deterioration if not repaired and sealed properly. I recommend repair as needed. \$250 - \$500

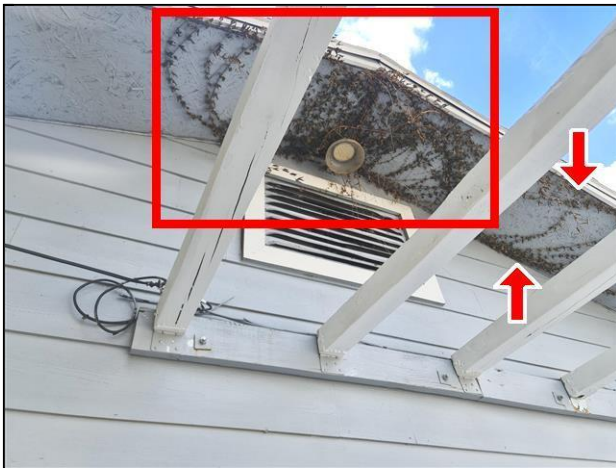
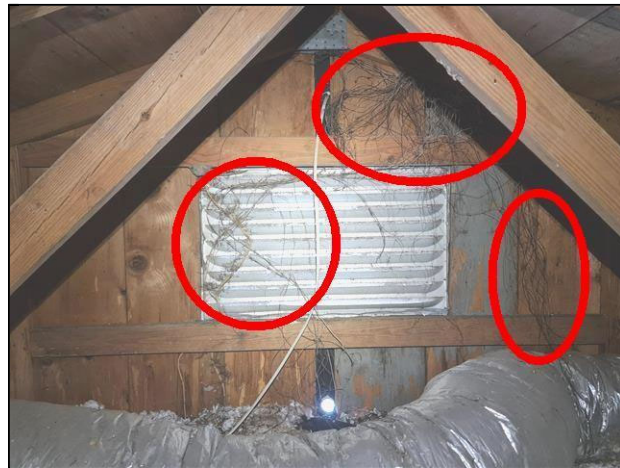
**There is excess vegetation around the home that should be trimmed or removed.**

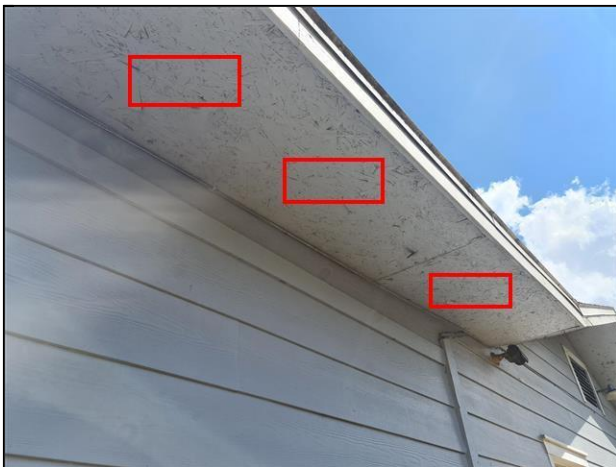
2.5 Item 1(Picture)

**I recommend increasing the ventilation to promote the life expectancy of roof covering.**

**I recommend increasing the ventilation to promote the life expectancy of roof covering.**
 \$501 - \$1000

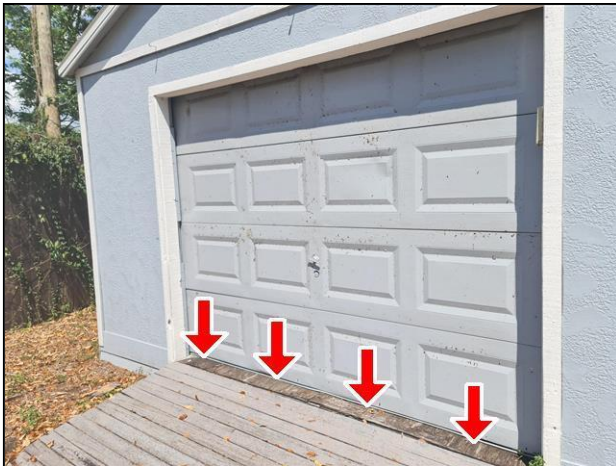
3.2 Item 1(Picture)

**The wood floor of garage is deteriorated and does not appear strong enough to continue to support a vehicle. There is a concern that floor may not be safe. A qualified person should repair as needed.**

**The wood floor of garage is deteriorated and does not appear strong enough to continue to support a vehicle. There is a concern that floor may not be safe. A qualified person should repair as needed.**
 \$1,000 - \$2,500

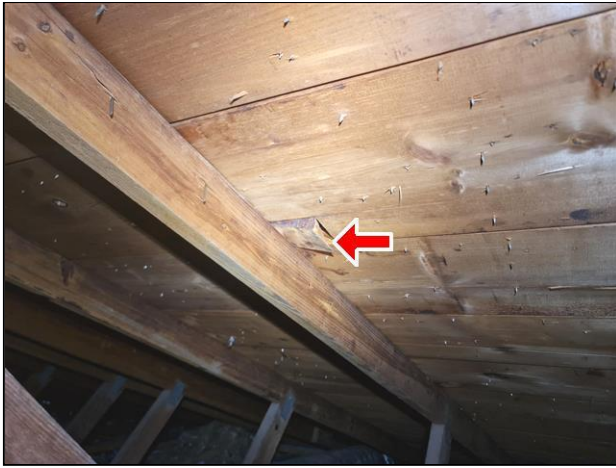
5.5 Item 1(Picture)

**The roof sheathing is damaged in areas. The damage to this area is not significant to require replacing at this time. Recommend waiting until roof covering is replaced. I recommend a qualified contractor perform the work.**

**The roof sheathing is damaged in areas. The damage to this area is not significant to require replacing at this time. Recommend waiting until roof covering is replaced. I recommend a qualified contractor perform the work. \$501 - \$1000**

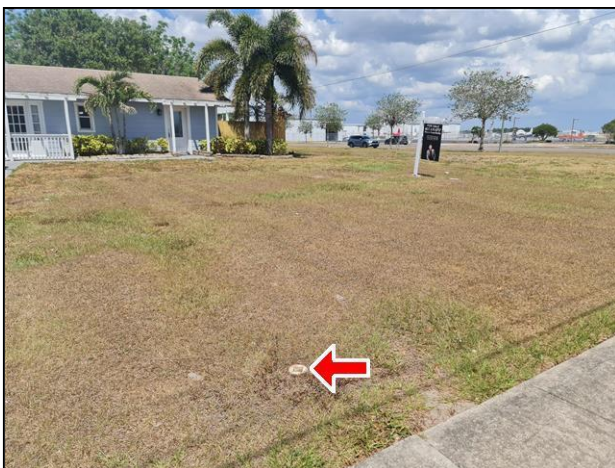
6.0 Item 1(Picture)

(1) The sewer clean out is located at the South side of home.

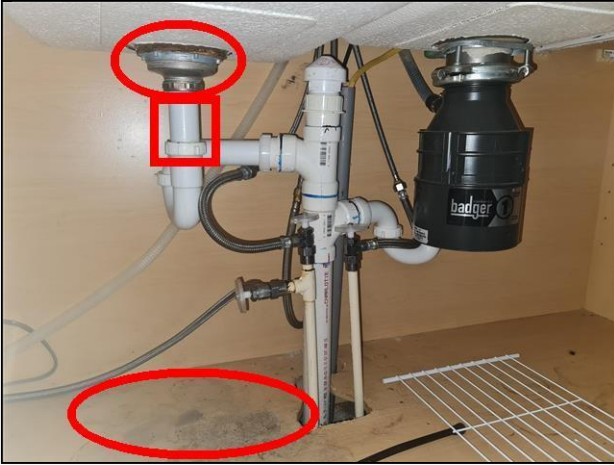
6.0 Item 2(Picture)

(2) The kitchen sink basket and drain line are leaking at the left of kitchen sink. Repairs are needed to stop leaking water from damaging the cabinet bottom or to eliminate moisture that may contribute to organic growth. A qualified person should repair or replace as necessary.

(2) The kitchen sink basket and drain line are leaking at the left of kitchen sink. Repairs are needed to stop leaking water from damaging the cabinet bottom or to eliminate moisture that may contribute to organic growth. A qualified person should repair or replace as necessary.

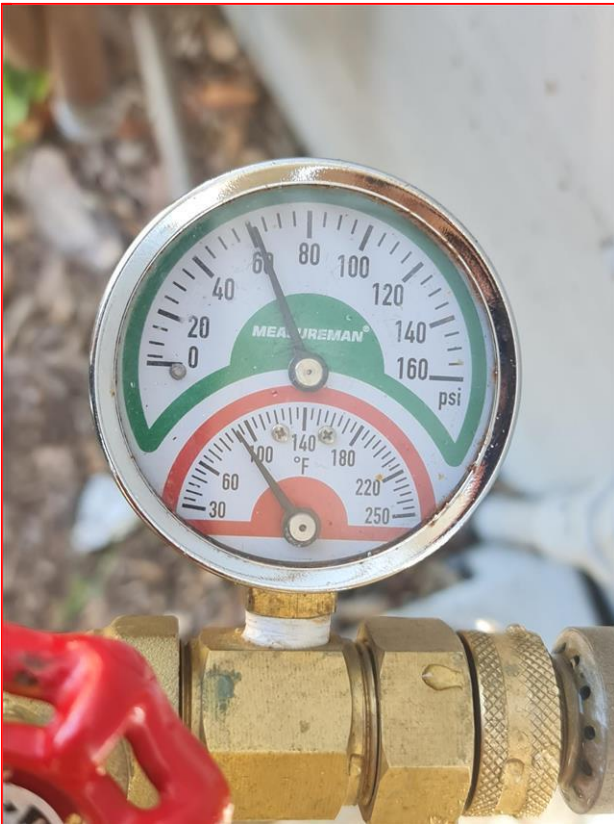
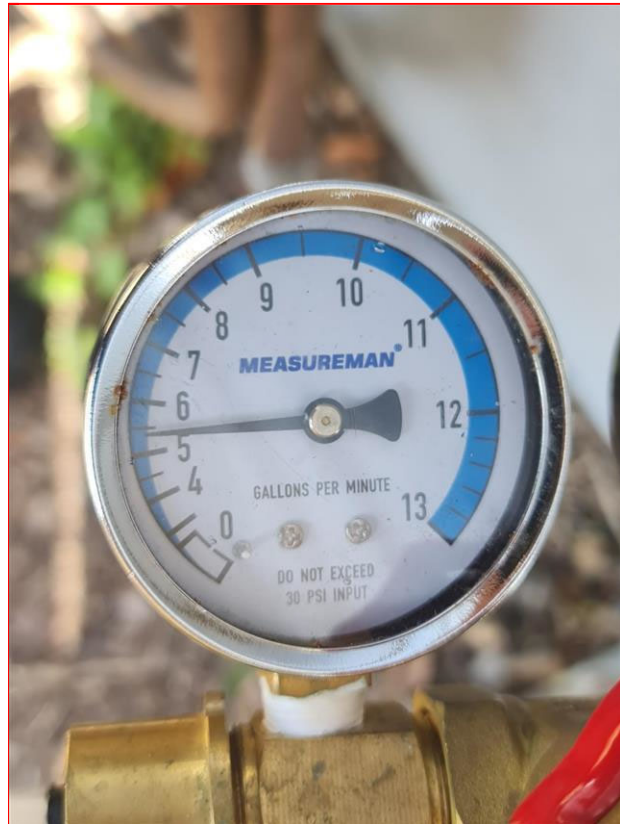
6.1 Item 1(Picture)

(1) The water pressure was recorded at 60 PSI (pounds per square inch) and the volume was recorded at 5.5 GPM (gallons per minute) at the time of inspection.

A normal range in water pressure is 30 PSI - 80 PSI. A normal range in water volume is 6-12 GPM.

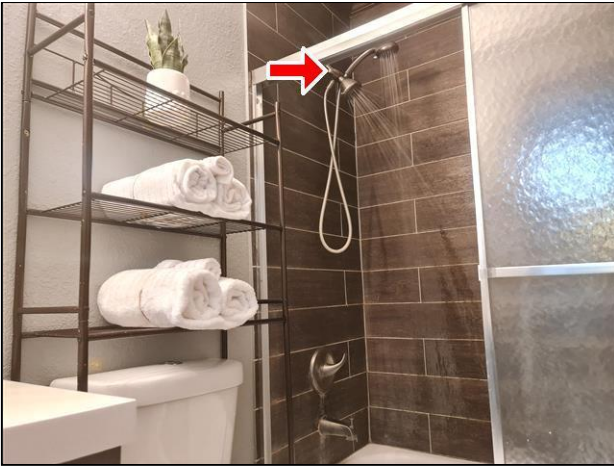
6.1 Item 3(Picture)

(2) The shower head and diverter is leaking at the hall bath. Repairs are needed. I recommend repair or replace as desired.

(2) The shower head and diverter is leaking at the hall bath. Repairs are needed. I recommend repair or replace as desired.

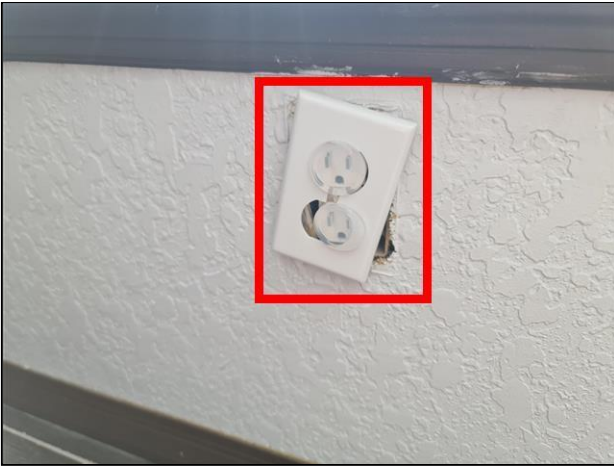
7.3 Item 1(Picture)

**One receptacle has a broken or damaged cover-plate in the small bedroom (left side of home). This is a safety issue that needs to be corrected. I recommend repair as needed.**

- One receptacle has a broken or damaged cover-plate in the small bedroom (left side of home). This is a safety issue that needs to be corrected. I recommend repair as needed.
\$0 - \$100

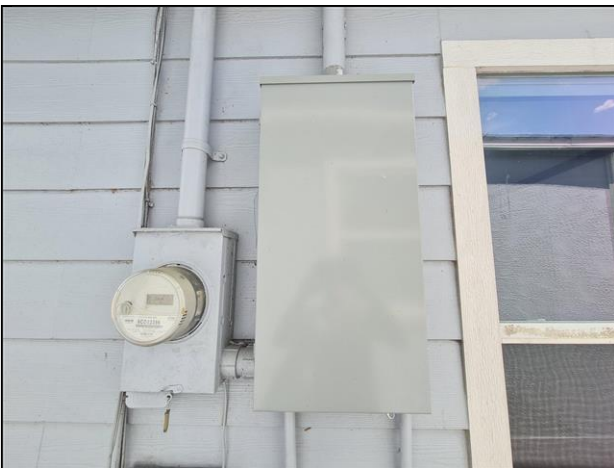
7.7 Item 1(Picture)

(1) The main panel box is located at the North side of the home.

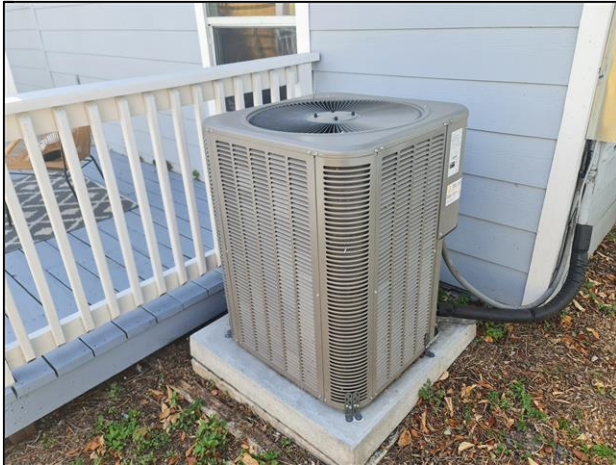
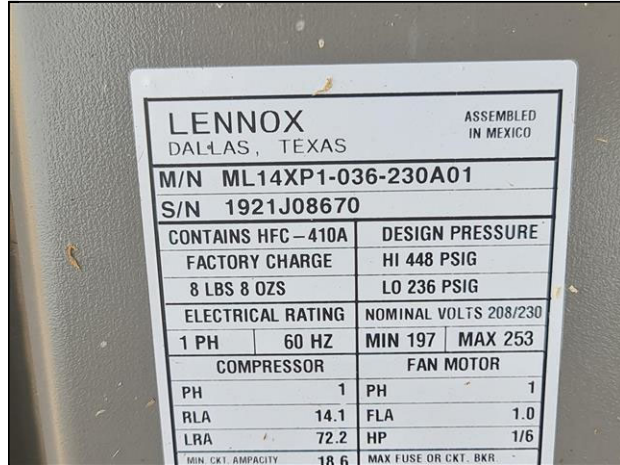
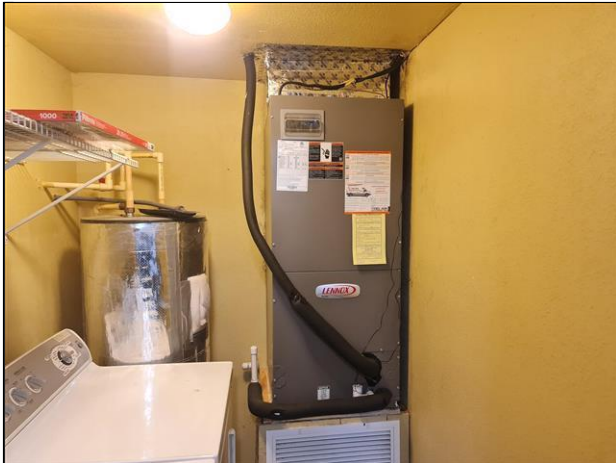
8.8 Item 1(Picture)

(1) According to the data plates the condenser unit was manufactured in 2021 and the air handler unit was manufactured in 2021. The condenser unit is a 3 ton and the air handler is a 3 ton.

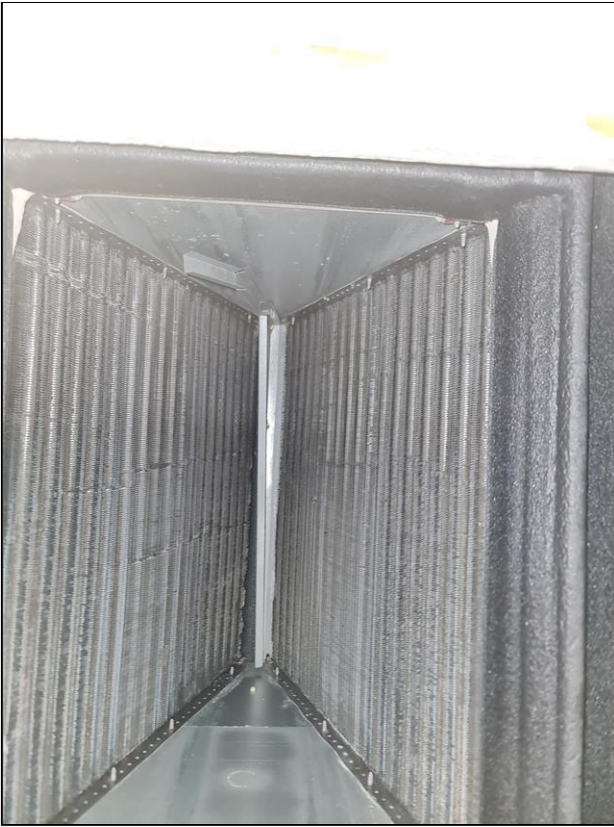
8.8 Item 5(Picture)

(2) The evaporator coils at the air handler were clean and in good condition at the time of inspection.

Dirty coils can cause the HVAC unit to run longer cycles, not cool or heat efficiently, and produce higher energy bills. It is recommended a licensed HVAC contractor service unit. This is for your information.

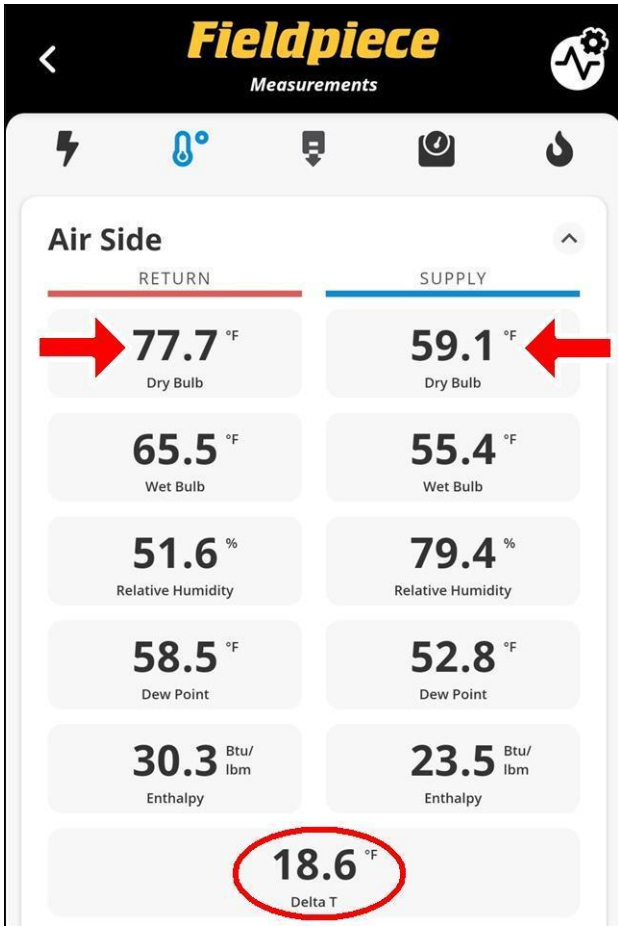
8.10 Item 1(Picture)

The air conditioning unit was tested using a method called Delta-T or Temperature Split. Air temperature was measured near the return (at the filter side) and at the supply. A normal operating system will have a difference of 15-20 degrees between these two temperature measuring locations.

These were the readings at the time of inspection. This indicates that the range in temperature drop is normal. No action is needed. This is for your information.

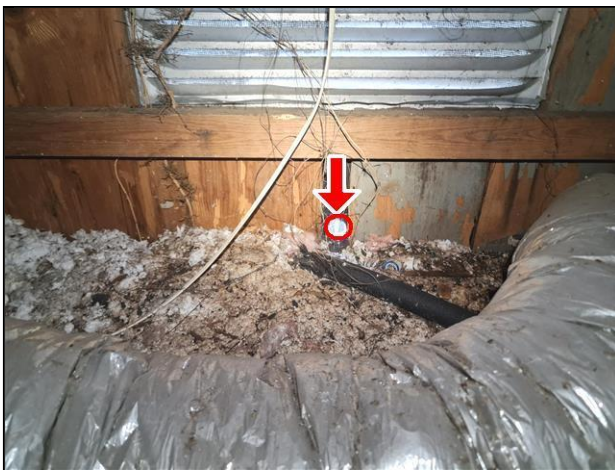
9.0 Item 1(Picture)

(1) Evidence of pests were found in the attic. It appears they're entering through a hole beneath the gable vent at the right side (facing front). Sometimes pests can cause damage to home or components. A pest control company should inspect further and correct as needed.

(1) Evidence of pests were found in the attic. It appears they're entering through a hole beneath the gable vent at the right side (facing front). Sometimes pests can cause damage to home or components. A pest control company should inspect further and correct as needed.

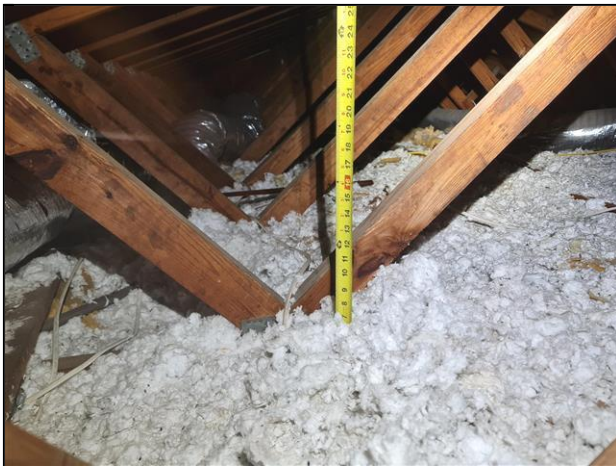
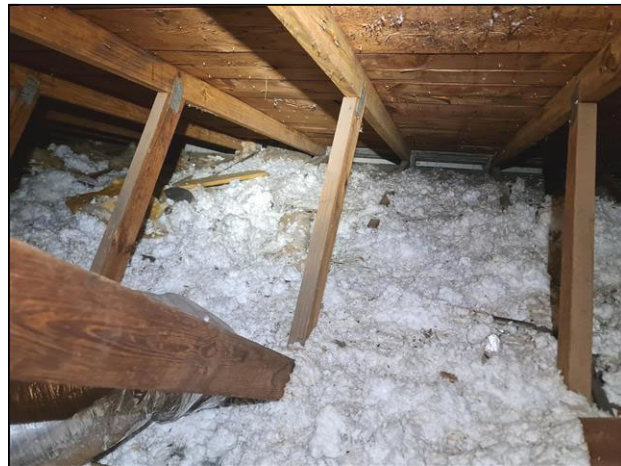
9.0 Item 4(Picture)

(2) The attic insulation is about seven inches thick or 25.6 R-Value.

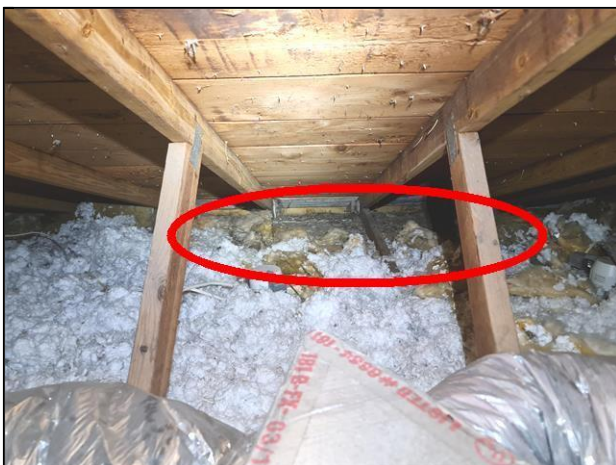
9.0 Item 6(Picture)

(3) Insulation is missing in certain areas in attic. Insulation that has fallen to the ground or has become damp from the ground or from condensation usually needs to be replaced with new insulation. A qualified person should repair or replace as needed.

(3) Insulation is missing in certain areas in attic. Insulation that has fallen to the ground or has become damp from the ground or from condensation usually needs to be replaced with new insulation. A qualified person should repair or replace as needed.

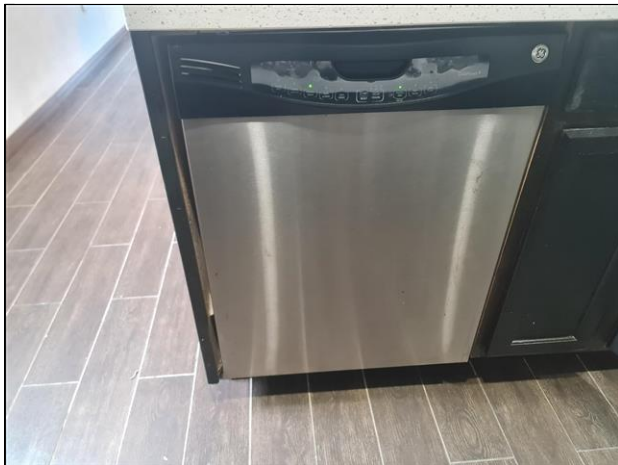
10.0 Item 1(Picture)

The dishwasher was tested and found to be functional at the time of inspection.

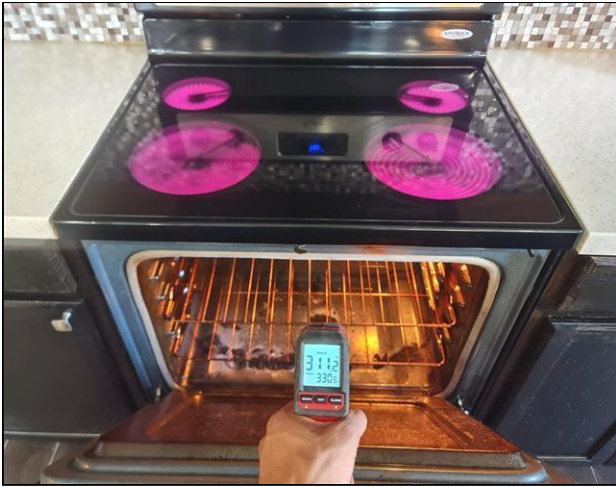
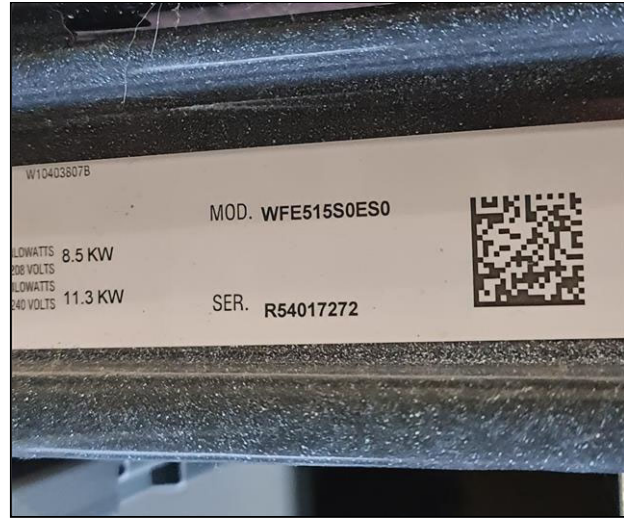
10.1 Item 1(Picture)

(1) The range was tested and found to be functional at the time of inspection.

(2) **The anti tip bracket is missing. This bracket is used to prevent the range from tipping forward and potentially spilling hot contents. I recommend repair as needed.**

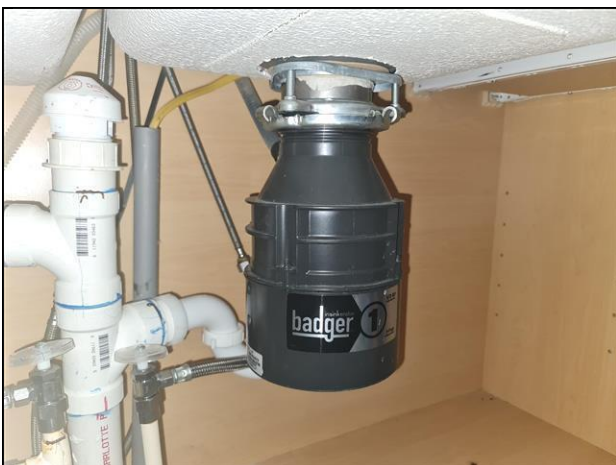
10.3 Item 1(Picture)

The garbage disposal was tested and found to be functional at the time of inspection.

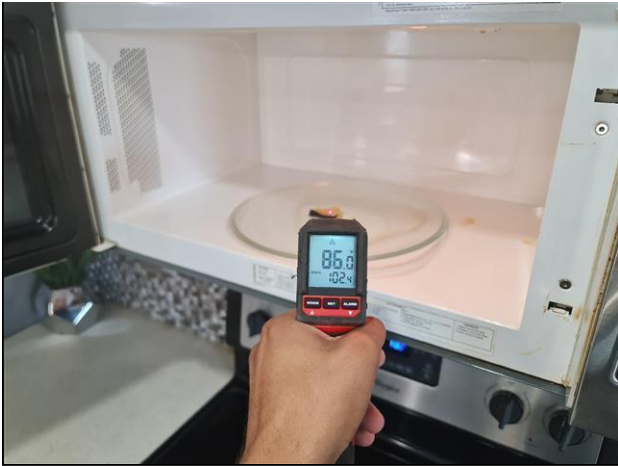
10.5 Item 1(Picture)

The microwave was tested and found to be functional at the time of inspection.

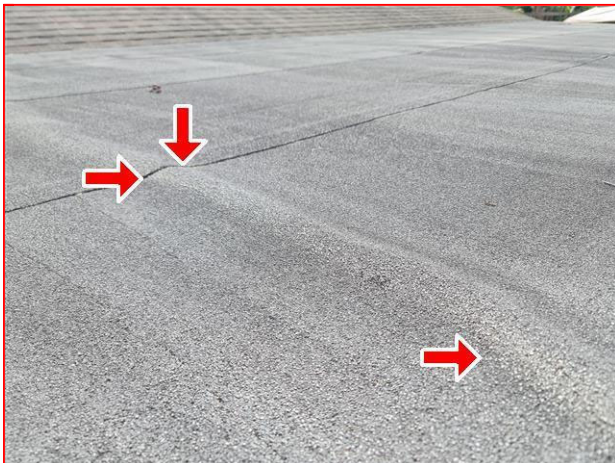
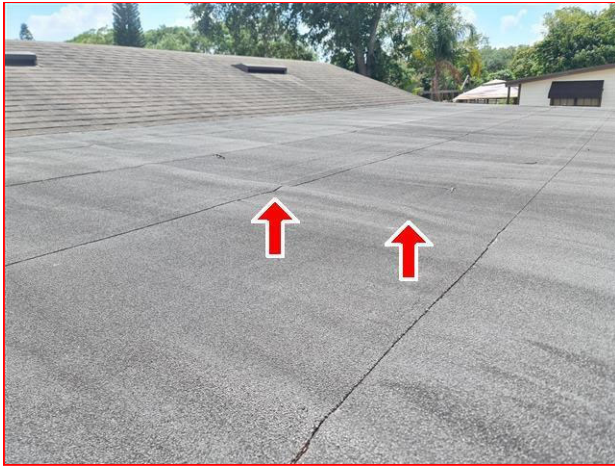
1.0 Item 5(Picture)

(2) The roof covering has curled or brittle membrane (modified bitumen) at the several areas of the roof. This area should be repaired or replaced This area may leak in the near future. I recommend monitor and repair or replace if the problem continues or becomes worse.

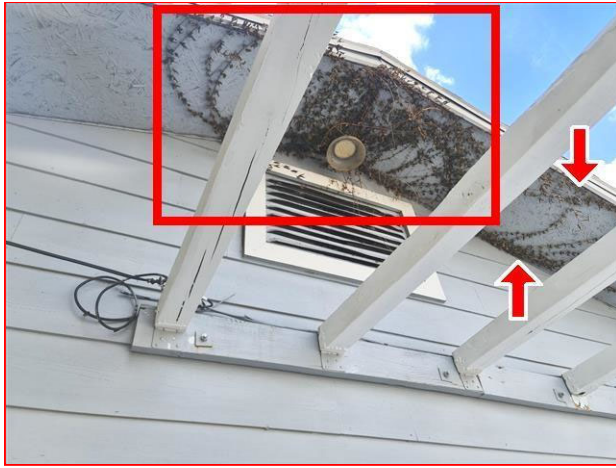
2.4 Item 1(Picture)

There is excess vegetation around the home that should be trimmed or removed. \$101 - \$250

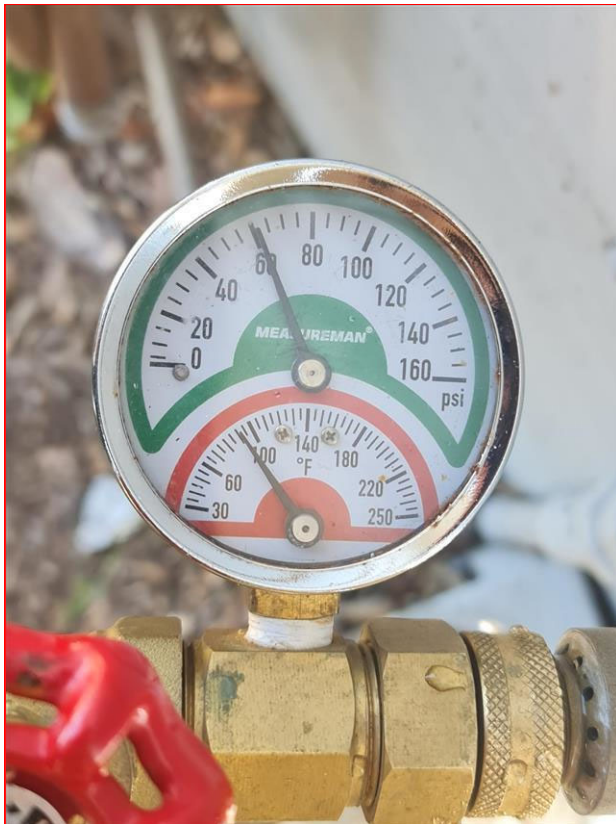
6.1 Item 1(Picture)

(1) The water pressure was recorded at 60 PSI (pounds per square inch) and the volume was recorded at 5.5 GPM (gallons per minute) at the time of inspection.

A normal range in water pressure is 30 PSI - 80 PSI. A normal range in water volume is 6-12 GPM.
