HUD
Engineering Certification
Report

1234 Sample

Lakeland, FL

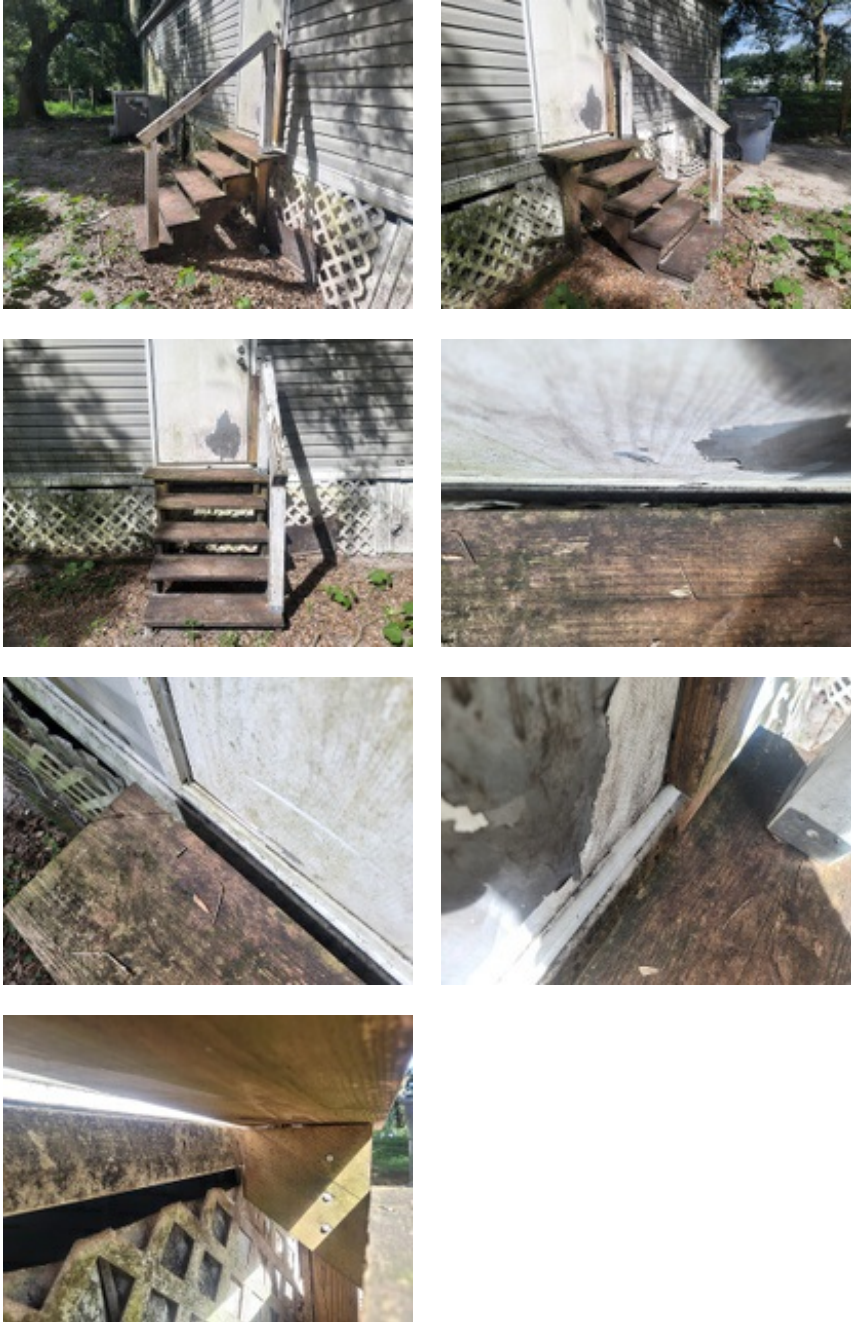
3.2 Images

Back/Rear

N/A: Independent posts next to the home support the portion of the floor structure which is up against the home.

No roof structure present.

The Mfd. home **does not appear to have been** modified or altered with respect to this addition.

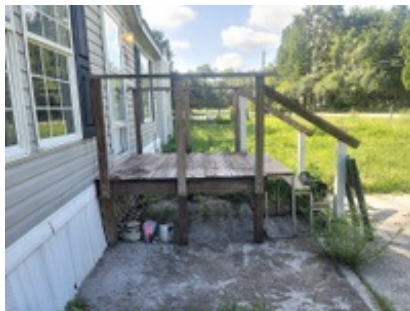
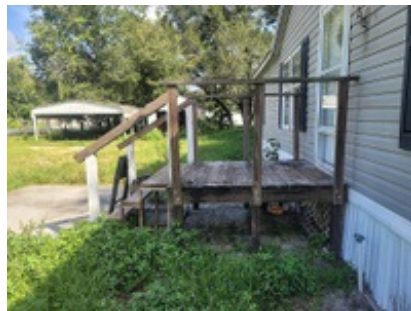
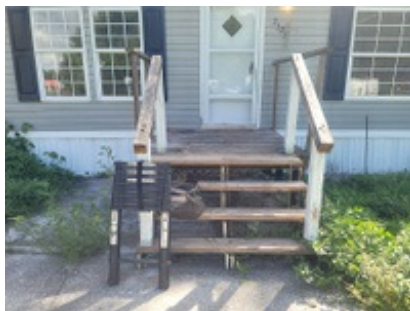
3.8 Images

Front

N/A: The Independent posts are connected up against the home by a 2x6 board and drywall screws. The deck is supported by independent posts. The age of the addition appears to be older material.

No roof structure present.

The Mfd. home **does not appear to have been** modified or altered with respect to this addition.
